PHOTOGRAPHIC INTERPRETATION REPORT

LAUNCH AREA B PLESETSK ICBM COMPLEX, USSR

NPIC/R-403/64

June 1964

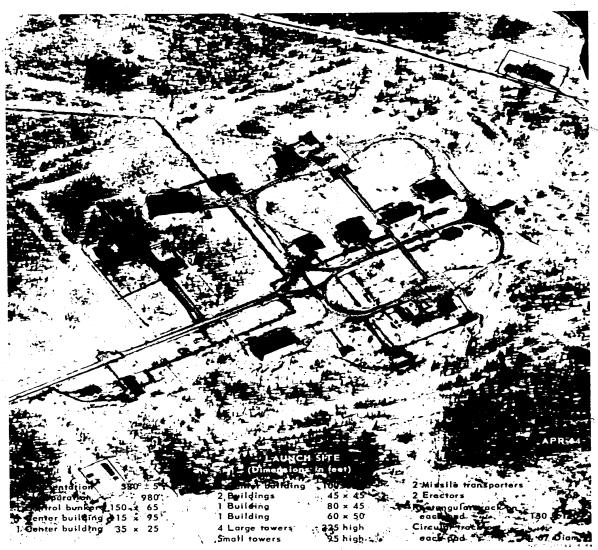
FIGURE 2. LAUNCH SITE.

Site security consists of an outer security fence and a closely spaced, triple inner security fence. Midway between the outer fence and the triple inner fence is a well-defined patrol path. There is a probable guardhouse immediately outside the fenced area. No guard towers can be distinguished.

Each elongated pad has its central part marked off by a square trace within which a circular trace is centered around the Jaunch platform. The purpose of these markings has

not been determined. On at least one mission the square trace was visible on a snow-covered pad. On occasion it is not visible, or a part may be obscured or missing. Its height, if any, is not determinable...

An erector is present at the rear of each launch platform and appears to be of the same height and width as the platform. The outline of the erector appears rectangular, with protuberances along the center of the left side and at the rear. The right pad has a mottled appearance. A very tall steel lattice tower is placed on each side of each pad so that a line connecting them passes through or very near to the launch plata.

positioned closer to the pad than the other three. each pad.

forms. The inboard tower at the right pad is Two very small buildings are adjacent to

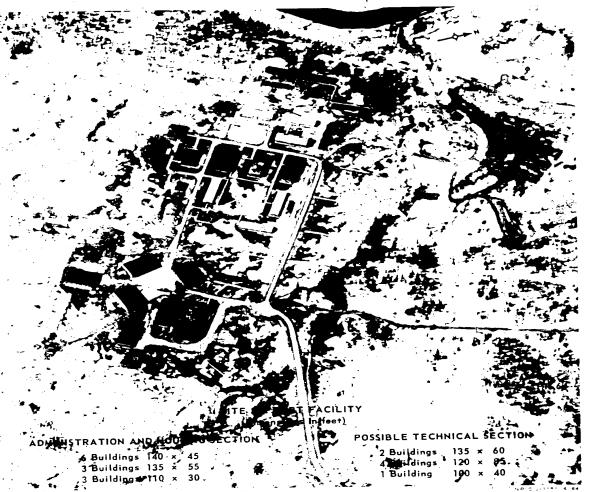
FIGURE 4. SITE SUPPORT FACILITY.

feet south-southwest of the launch site and consists of an administration and housing section and a possible technical section. A single se- cellent road network.

The site support facility is located 4,000. curity fence encompasses the latter and part of the former, and divides them one from another. The wholesfacility is served by an ex-
